# 11-38. TSF LEAKAGE RISK

Treatment of contaminants in the TSF is not presented in the EIS. The TSF is planned to be constructed on a fault. 1.6 ML/day of TSF leakage is planned without considering the fault risk. The planned monitoring places few controls on compliance with the design and there is no contingency plan to remediate leakage. No peer review of contamination risks has been presented.

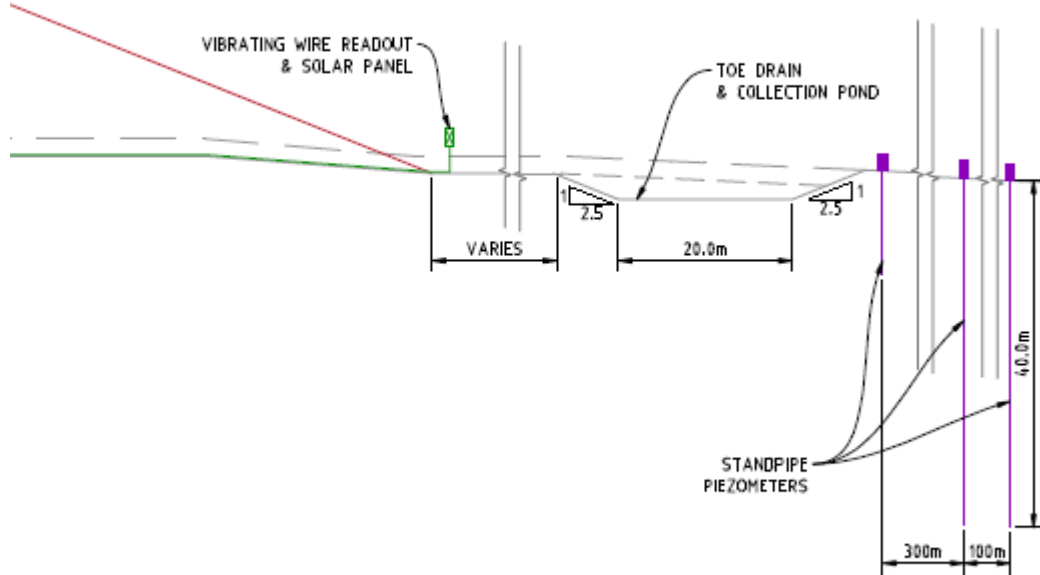
Figure 1: Indicative design of conceptual seepage collection pond(s). Source – Figure 18 of (ATC Williams, 2020)

26). While the trigger for action is not stated, the proposed 'contingency' is to build more seepage collection down gradient.

The indicative seepage collection infrastructure (Figure 1) is valid for a small area due west of the TSF (see Figure 2).

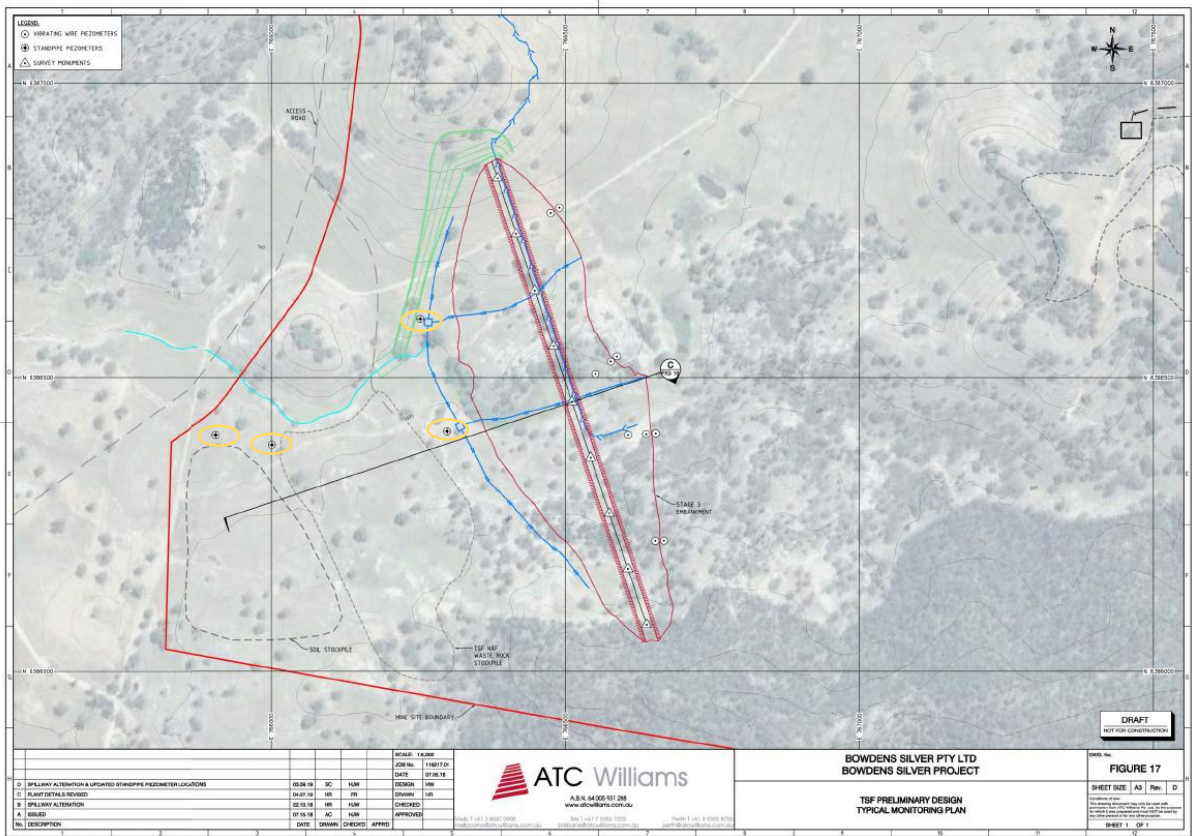
Figure 2: Four planned piezometers for leakage monitoring. Source - Figure 17 (ATC Williams, 2020)

To calibrate this estimate, four standpipe piezometers are proposed near the embankment. None are listed around the TSF to detect leakage towards Lue Village or to monitor leakage into the pit lake.

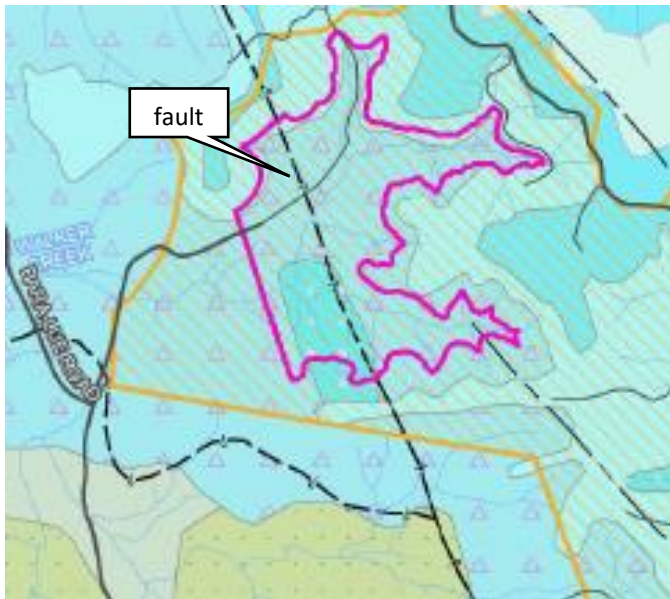
Figure 3: Structural geology – adapted from Figure 11 of (Jacobs (Australia), 2020, pp. 5-57)

Faults have the potential to readily transmit large quantities of groundwater. The only reference to the faults mapped beneath the planned TSF is on page 2 of ATC Williams (2020). ATC Williams (2020 p.2) suggest leakage through faults (Figure 3) is considered in 'Section 7'. Transmissive faults can form a highly transmissive underground flow conduit in a preferred direction, potentially to a significant receptor. No reference to faults

can be seen in Section 7 and the TSF design and monitoring plan in ATC Williams (2020) does not appear to consider the leakage risk posed by faulting (ATC Williams, 2020).
